**ANNUAL INSPECTION BY PROFESSIONAL ENGINEER  
CCR RULE, SECTION 257.83(b)  
EMPIRE DISTRICT ELECTRIC COMPANY  
ASBURY POWER PLANT  
EXISTING CCR IMPOUNDMENTS  
ASBURY, MISSOURI**

PROJECT NUMBER: 231518

January 18, 2016

RE: Annual Inspection by Professional Engineer  
CCR Rule, Section 257.83(b)  
Empire District Electric Company  
Asbury Power Plant . Existing CCR Impoundments  
Asbury, Missouri  
PPI Project Number: 231518

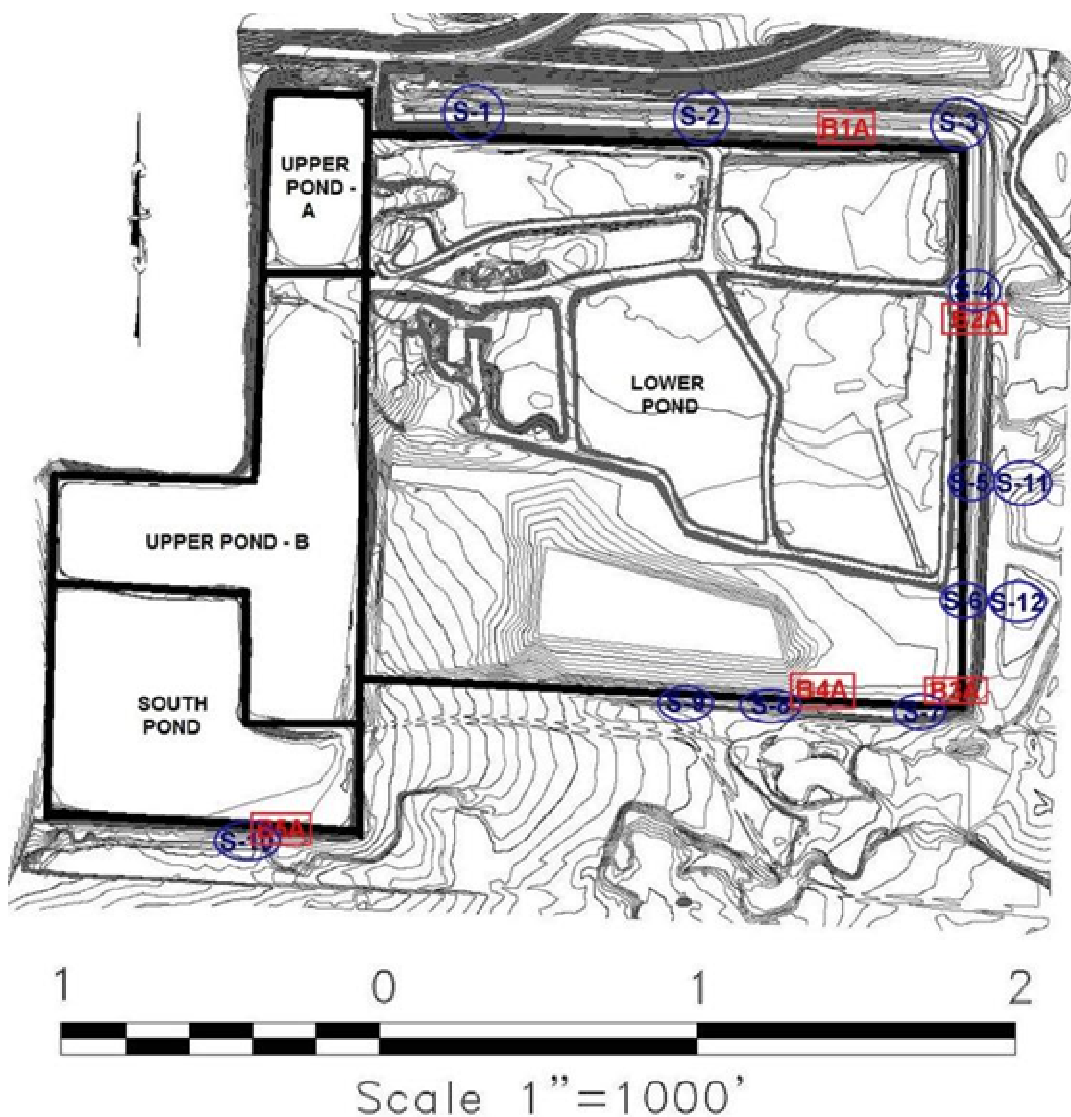
2. Locations and type of any existing instrumentation and the maximum recorded readings of each instrument since the previous annual inspection: Existing instrumentation pertinent to structural stability at the Asbury CCR Impoundments includes five (5) groundwater piezometers and twelve (12) settlement monuments. This instrumentation has been monitored monthly since October 2015, in accordance with Section 257.83(a) of the CCR Rule. The general configuration of the CCR Impoundments and the approximate locations of the instrumentation are shown in the figure below.

Water level readings in the piezometers have been relatively stable since they were installed in 2012. The settlement monuments have also been stable since they were

installed in 2012. SM-1 was disturbed by truck traffic shortly after installation. The tables below summarize baseline and recent readings for the piezometers and settlement monuments.
